Cedar Lake Improvement Study and Management Plan Van Buren County, Michigan

Provided for: Cedar Lake Recreation Association (CLRA) Board

**Prepared by: Restorative Lake Sciences
Jennifer L. Jermalowicz-Jones, PhD
Water Resources Director
18406 West Spring Lake Road
Spring Lake, Michigan 49456
www.restorativelakesciences.com**

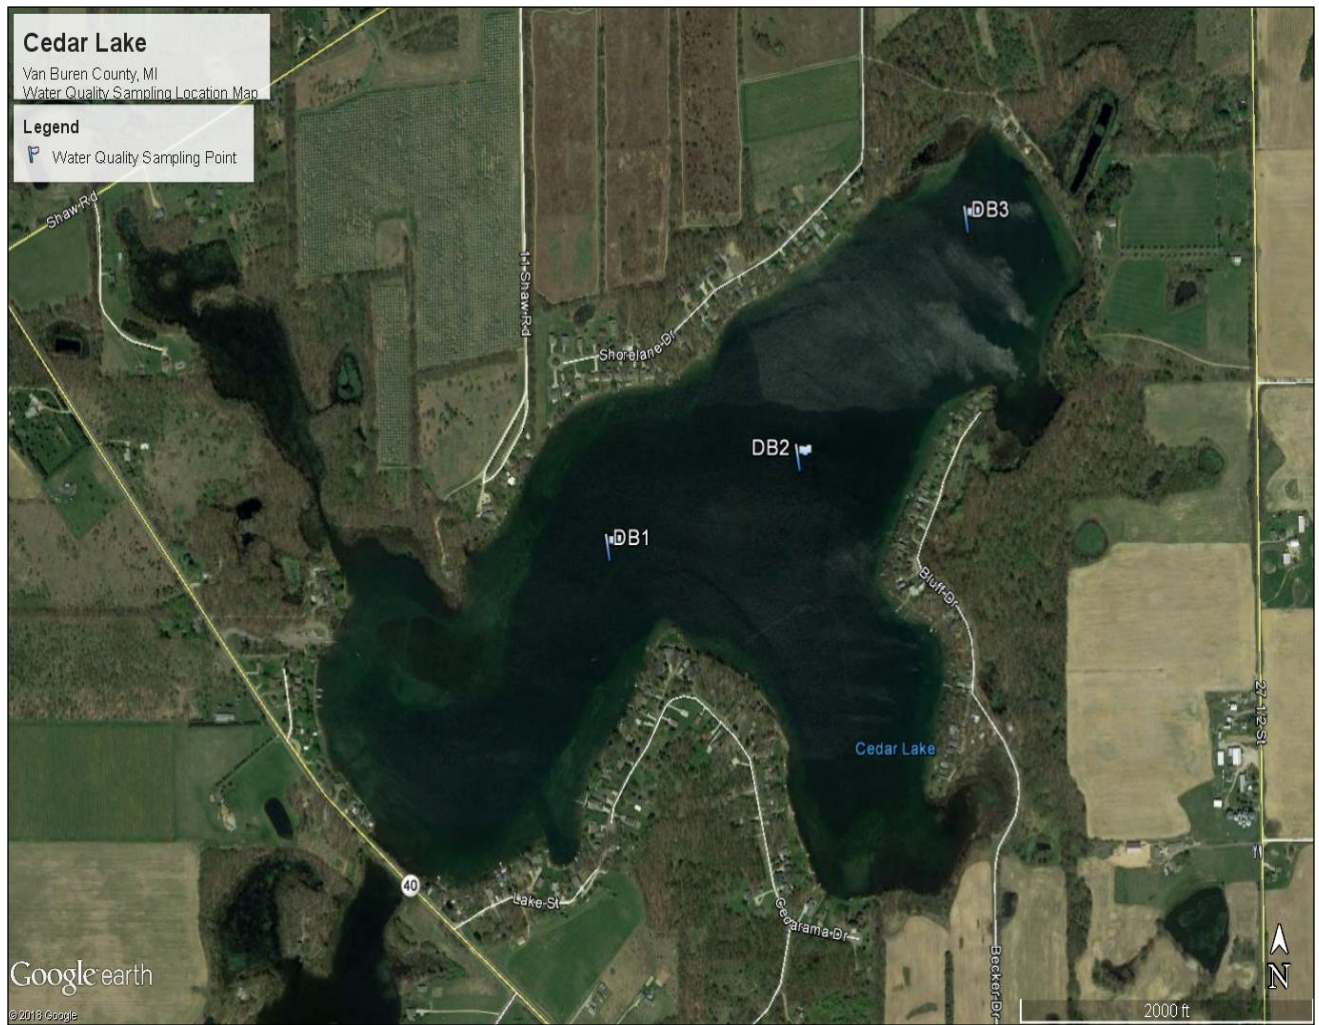
Figure 7. Locations for water quality sampling of the 3 basins in Cedar Lake, Van Buren County, Michigan (September 20, 2017).

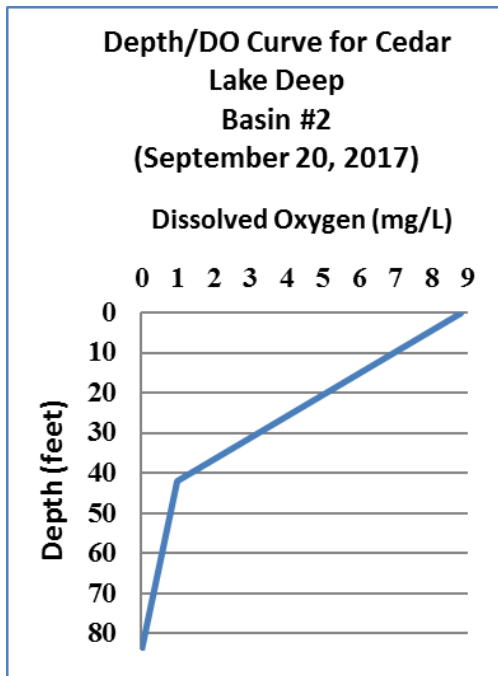
Figure 9. Dissolved oxygen/depth profiles for the 3 deep basins in Cedar Lake, Van Buren County, Michigan (RLS, 2017).

Dissolved oxygen is a measure of the amount of oxygen that exists in the water column. In general, dissolved oxygen levels should be greater than 5 mg/l to sustain a healthy warm-water fishery. Dissolved oxygen concentrations may decline if there is a high biochemical oxygen demand (BOD) where organismal consumption of oxygen is high due to respiration. Dissolved oxygen is generally higher in colder waters. Dissolved oxygen was measured in milligrams per liter (mg/l) with the use of a calibrated Eureka Manta II® dissolved oxygen meter. During the summer months, dissolved oxygen at the surface is generally higher due to the exchange of oxygen from the atmosphere with the lake surface, whereas dissolved oxygen is lower at the lake bottom due to decreased contact with the atmosphere and increased biochemical oxygen demand (BOD) from microbial activity. Dissolved oxygen concentrations during the September 20, 2017 sampling event ranged from 0.0-8.6 mg/l, with concentrations of dissolved oxygen higher at the surface and much lower at the bottom. Figure 9 below shows the changes in dissolved oxygen with depth in the 3 deep basins of Cedar Lake. The dissolved oxygen concentration declines with depth in all basins but most prominently in deep basin #2 which is the deepest of the 3 basins.

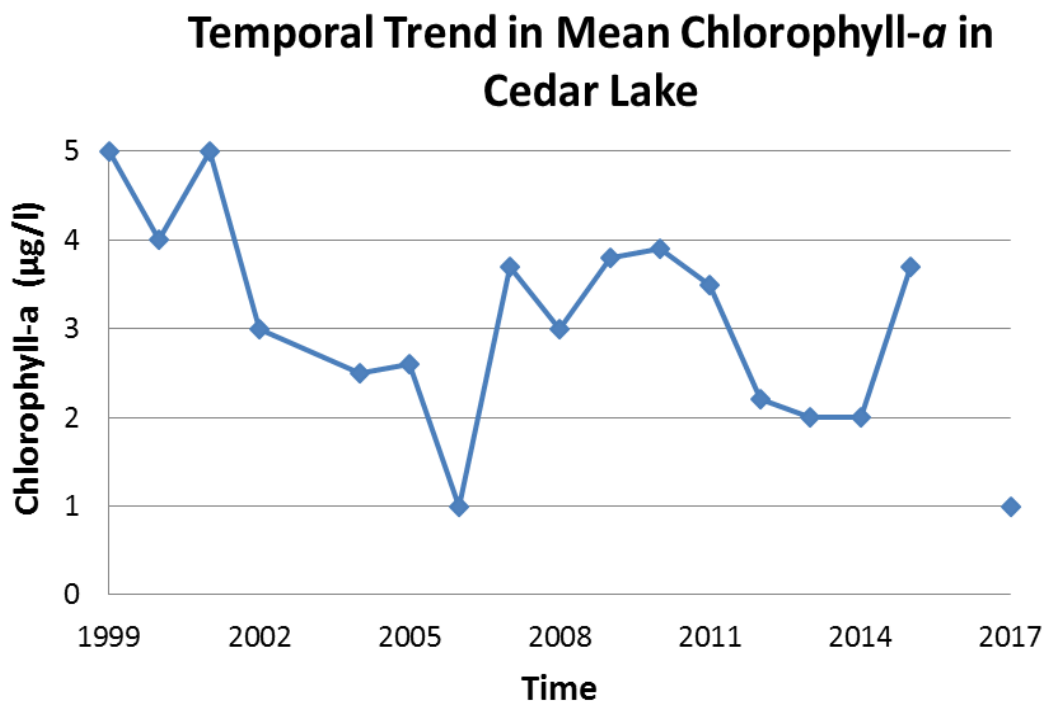
Figure 17. Graph of changes in mean chl-*a* with time in Cedar Lake, Van Buren County, Michigan (data sources include CLMP and RLS data).

Chlorophyll-*a* is a measure of the amount of green plant pigment present in the water, typically in the form of planktonic algae. High chlorophyll-*a* concentrations are indicative of nutrient-enriched lakes. Concentrations greater than 6 µg/l are found in eutrophic or nutrient-enriched aquatic systems, whereas chlorophyll-*a* concentrations less than 2.2 µg/l are found in nutrient-poor or oligotrophic lakes. Chlorophyll-*a* is measured in micrograms per liter (µg/l) with the use of a calibrated in situ fluorimeter by Turner Designs®.

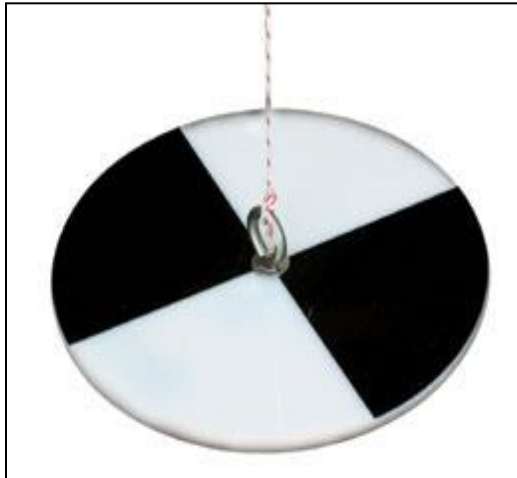
Figure 18. A Secchi disk

Secchi transparency is a measure of the clarity or transparency of lake water, and is measured with the use of an 8-inch diameter standardized Secchi disk (Figure 18). Secchi disk transparency was measured by lowering the disk over the shaded side of a boat around noon and taking the mean of the measurements of disappearance and reappearance of the disk. Elevated Secchi transparency readings are usually correlated with increased aquatic plant and algae growth. Eutrophic systems generally have Secchi disk transparency measurements less than 7.5 feet due to turbidity caused by excessive planktonic algae growth. Further, elevated phytoplankton and turbidity also are associated with decreased Secchi transparency. The Secchi transparency of Cedar Lake averaged 13.8 feet over the deep basins of Cedar Lake during the September 20, 2017 sampling event. This transparency is adequate to allow abundant growth of algae and aquatic plants in the majority of the littoral (shallow) zone of the lake. Secchi transparency is variable and depends on the amount of suspended particles in the water (often due to windy conditions of lake water mixing) and the amount of sunlight present at the time of measurement. The Secchi transparency has increased steadily over the past few years which has also allowed more light to penetrate to the lake bottom and increase potential for submersed aquatic plant growth. The water clarity of Cedar Lake may be increasing with time due to the activity of Zebra Mussels which are prevalent in the lake (discovered in the lake in 1998) and filter phytoplankton out of the water column which increases water clarity. Figure 19 below shows the mean Secchi transparency with time in Cedar Lake.

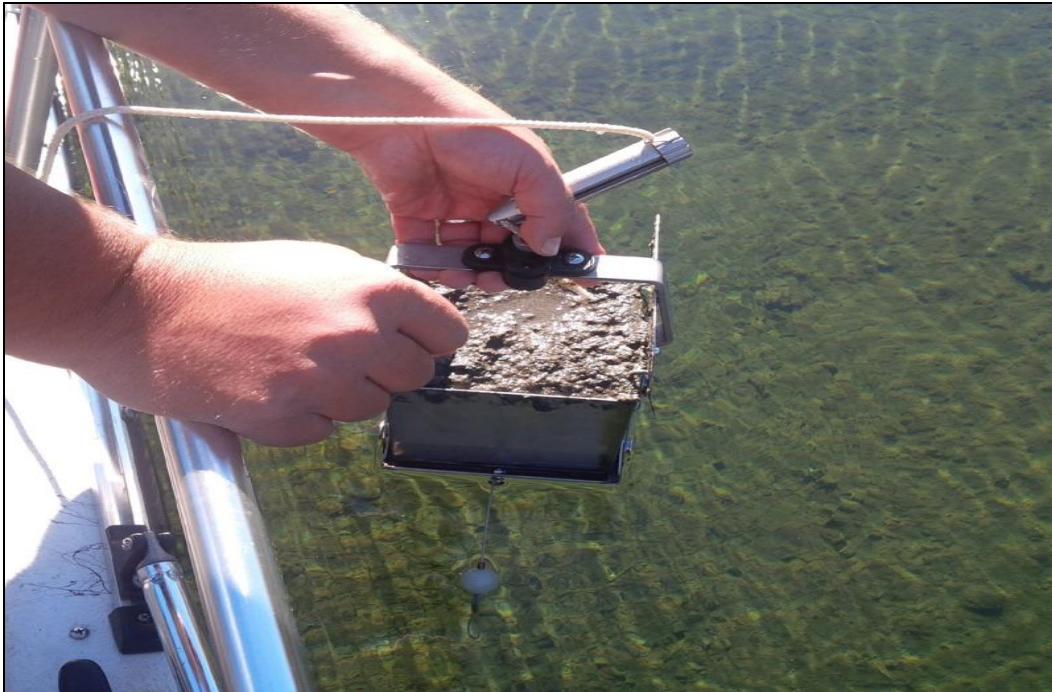
Figure 20. An Ekman hand dredge used to sample sediment macroinvertebrates in Cedar Lake, Van Buren County, Michigan.

Restorative Lake Sciences, LLC, collected sediment macroinvertebrates from 5 separate locations (north, south, east, west, and central regions) within Cedar Lake on September 20, 2017 (Table 8) using an Ekman hand dredge (Figure 20). The sampling found mayflies (*Hexagenia limbata*, Ephemeroptera), midges (Chironomidae), wheel snails (Planorbidae), fingernail clams (Sphaeriidae), freshwater shrimp (Gammaridae), segmented worms (Oligochaeta), pond snails (Physidae), and caddisfly larvae (Limnephilidae), among a few other taxa. While the species were native, some are located universally in low quality and high quality water. The midge larvae family Chironomidae can be found in both high and low quality water (Lenat and Barbour 1994). The mayfly, *Hexagenia limbata*, found within this lake, has been shown to be linked with good water quality.

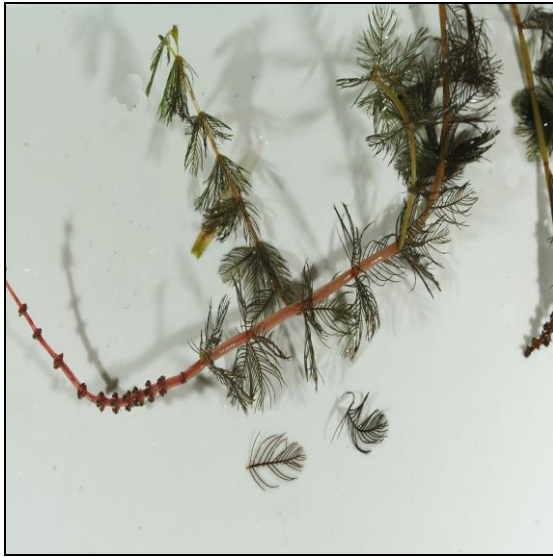
Figure 25. Eurasian Watermilfoil ©RLS

Hybrid Watermilfoil (*Myriophyllum spicatum* var. *sibiricum*; Figure 25) is an exotic aquatic macrophyte that is a serious problem in Michigan inland lakes and has been previously genetically determined in Cedar Lake. A similar watermilfoil species that is considered to be exotic by some scientists (*Myriophyllum heterophyllum*) in New Hampshire was found to have significant impacts on waterfront property values (Halstead et al., 2003). Moody and Les (2007) were among the first to determine a means of genotypic and phenotypic identification of the hybrid watermilfoil variant and further warned of the potential difficulties in the management of hybrids relative to the parental genotypes. It is commonly known that hybrid vigor is likely due to increased ecological tolerances relative to parental genotypes (Anderson 1948), which would give hybrid watermilfoil a distinct advantage to earlier growth, faster growth rates, and increased robustness in harsh environmental conditions. In regards to impacts on native vegetation, hybrid watermilfoil possesses a faster growth rate than Eurasian watermilfoil or other plants and thus may effectively displace other vegetation (Les and Philbrick 1993; Vilá et al. 2000). Approximately 5.8 acres of hybrid milfoil were found in Cedar Lake during the September 20, 2017 survey. It is possible that more may have existed prior to the lake study and was reduced due to recent treatments.

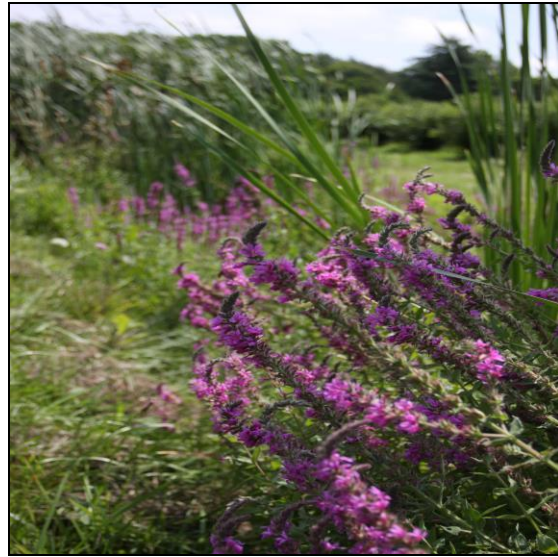
Figure 26. Purple Loosestrife ©RLS

Purple Loosestrife (*Lythrum salicaria*; Figure 26) is an invasive (exotic) emergent aquatic plant that inhabits wetlands and shoreline areas. It has showy magenta-colored flowers that usually bloom in mid-July and terminate in late September. The seeds are highly resistant to tough environmental conditions and may reside in the ground for extended periods of time. It exhibits rigorous growth and may out-compete other favorable native emergents such as cattails (*Typha latifolia*) or native swamp loosestrife (*Decodon verticillatus*) and thus reduce the biological diversity of Cedar Lake. The plant is spreading rapidly across the United States and is converting diverse wetland habitats to monocultures with substantially lower biological diversity. This plant was found in 9 locations around the lake shoreline.

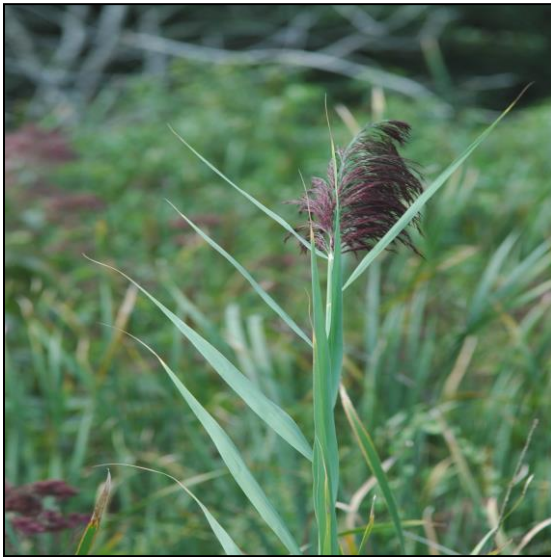
Figure 27. Phragmites ©RLS

The Giant Common Reed (*Phragmites australis*; Figure 27) was found in four locations along the shoreline of Cedar Lake and should be promptly removed before mitigation efforts become too costly due to rapid spread of the plant. *Phragmites* is an imminent threat to the surface area and shallows of the lake since it may grow submersed in water depths of ≥ 2 meters (Herrick and Wolf, 2005), thereby drying up wetland habitat and reducing lake surface area. In addition, large, dense stands of *Phragmites* accumulate sediments, reduce habitat variability, and impede natural water flow (Wang et al., 2006).

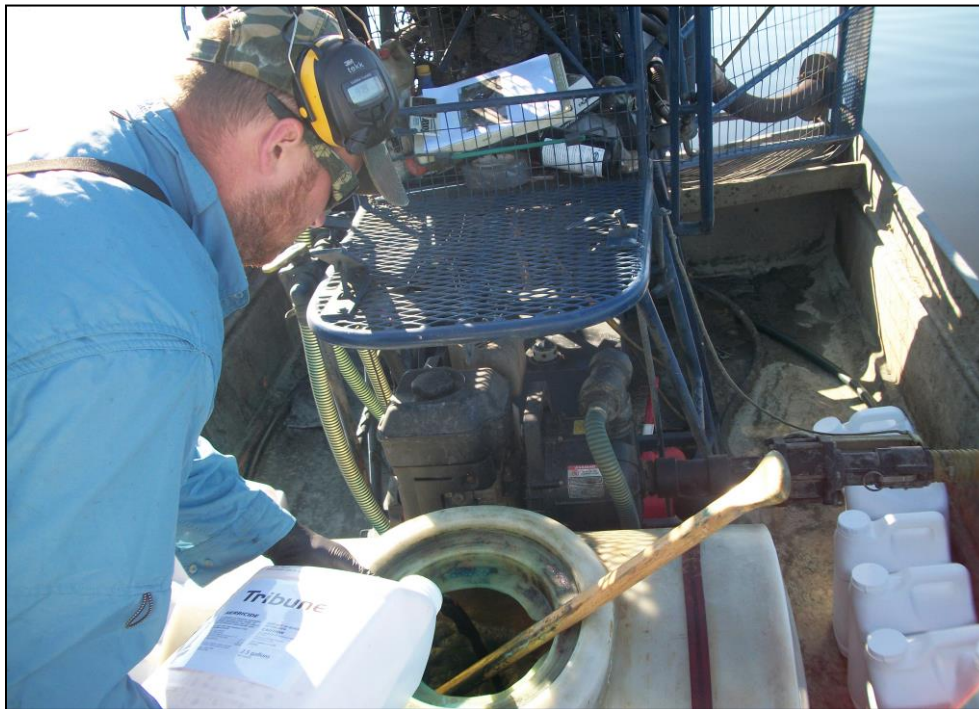
Figure 53. An herbicide treatment airboat and crew preparing for a lake treatment.

Systemic herbicides such as 2, 4-D and triclopyr are the two primary systemic herbicides used to treat Hybrid Watermilfoil. Fluridone (trade name, SONAR®) is a systemic whole-lake herbicide treatment that is applied to the entire lake volume in the spring and is used for extensive infestations. Fortunately, the patchy distribution of hybrid watermilfoil in Cedar Lake can be effectively spot-treated with granular triclopyr nearshore and granular 2,4-D or triclopyr in offshore areas. Triclopyr must be used in near shore areas with shallow well (< 30 feet deep) restrictions.

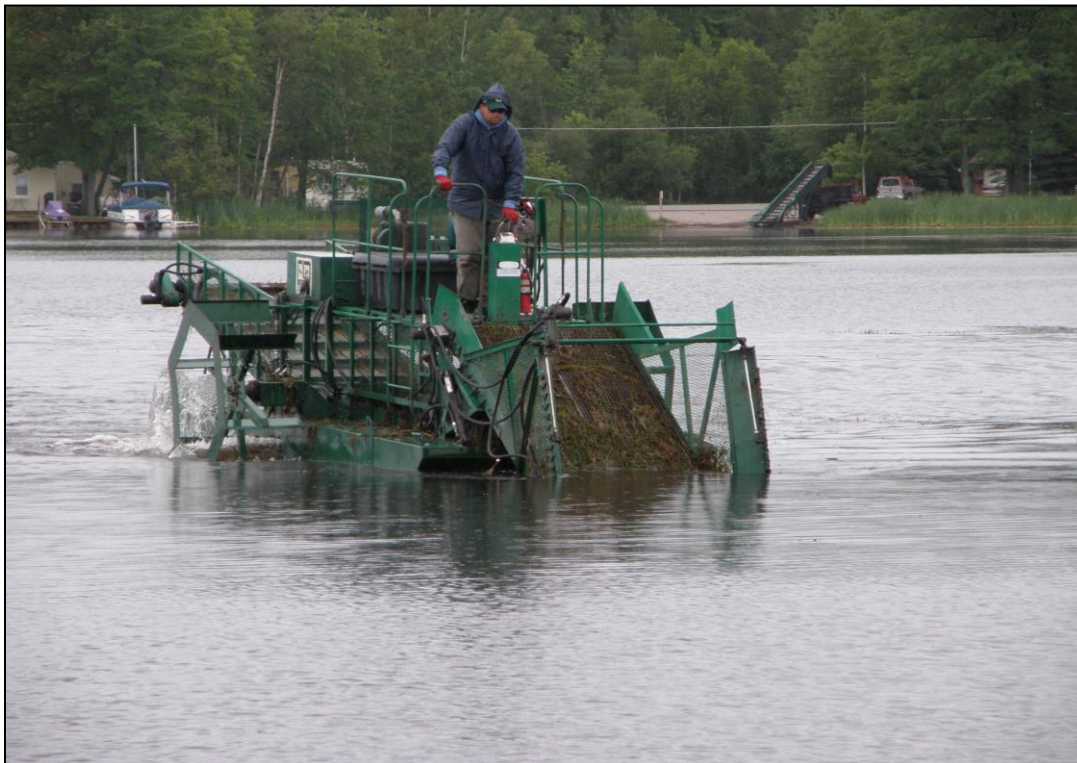
Figure 54. A mechanical harvester. Photo courtesy of Dave Foley.

Harvested plants are then taken to an offsite landfill or farm where they can be used as fertilizer. Mechanical harvesting is preferred over chemical herbicides when primarily native aquatic plants exist, or when excessive amounts of plant biomass need to be removed. Mechanical harvesting is usually not recommended for the removal of milfoil since the plant may fragment when cut and re-grow on the lake bottom. Mechanical harvesting does not require a permit from the Michigan Department of Environmental Quality (MDEQ); however, some counties require a launch site use permit from the Michigan Department of Natural Resources (MDNR) if a public access site is present. This technology would have the most efficacy on very large weed beds where milfoil is sparse or not present. It may also be useful in areas such as public boat launches to reduce nuisance native aquatic vegetation biomass. At this time, harvesting is not needed but could be used in the future if native aquatic plants grow dense in specific areas of the lake.

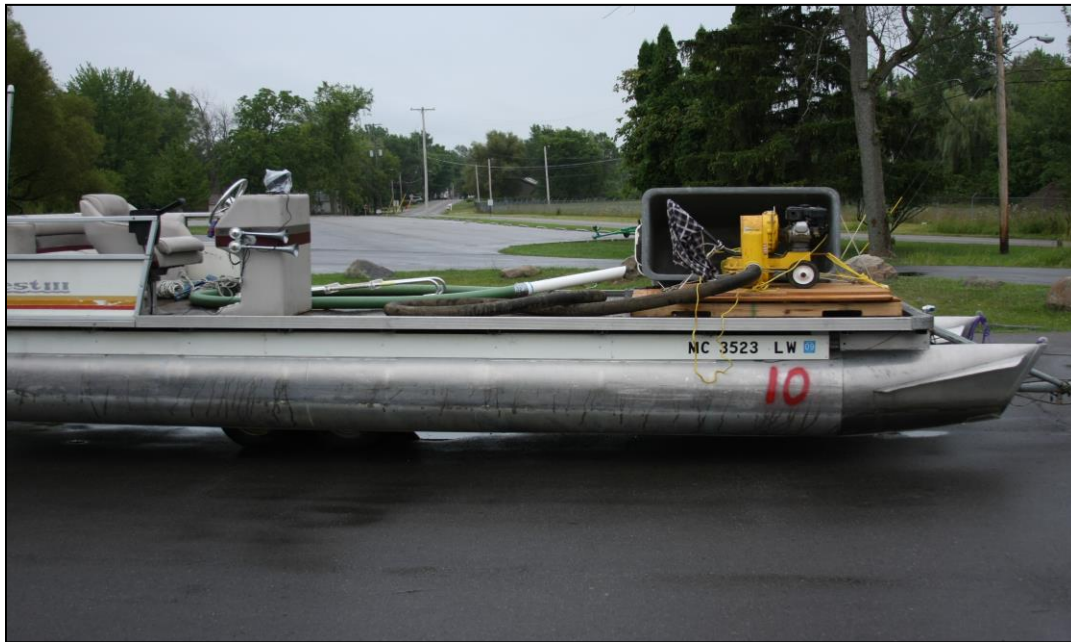
Figure 55. A DASH boat for hand-removal of watermilfoil or other nuisance vegetation.
©Restorative Lake Sciences, LLC

The advantage it has is that it can be selective in what species it removes since a diver is guiding the suction hose to targeted plants. This process may remove either plant material or sediments and requires a joint MDEQ/USACE bottomlands permit. Furthermore, this activity may cause re-suspension of sediments (Nayar et al., 2007) which may lead to temporarily increased turbidity and reduced clarity of the water.

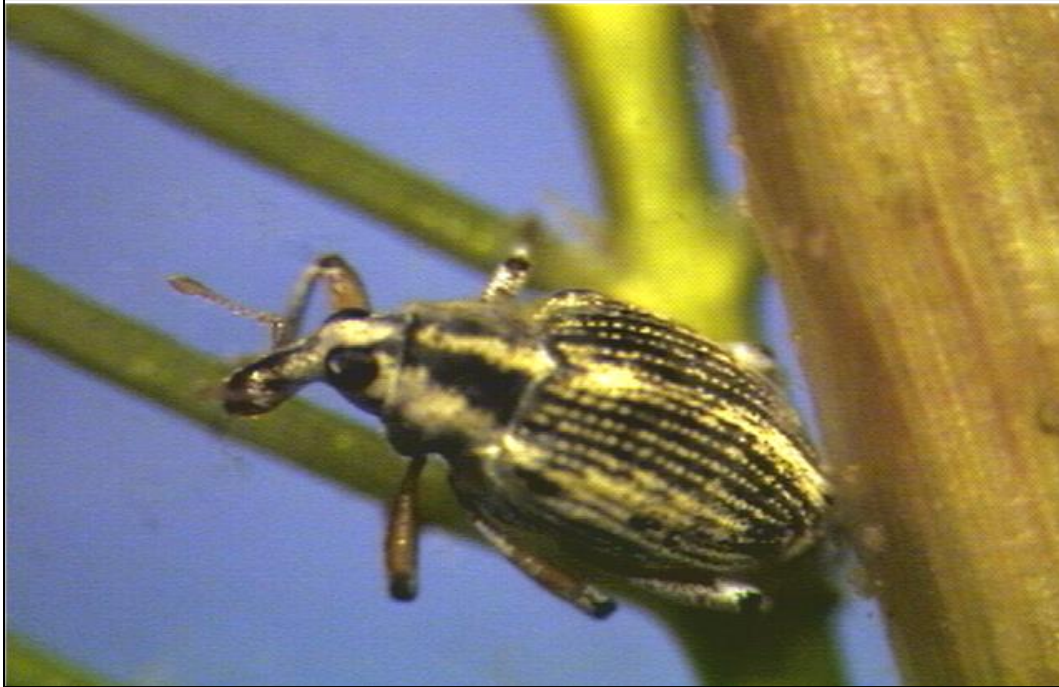
Figure 56. The watermilfoil weevil (*Euhrychiopsis lecontei*). Photo from R. Newman used with permission.

In the past, the use of the aquatic weevil, *Euhrychiopsis lecontei* (Figure 56) to control Hybrid Watermilfoil was implemented to reduce milfoil infestations and had highly variable results among and within lakes.

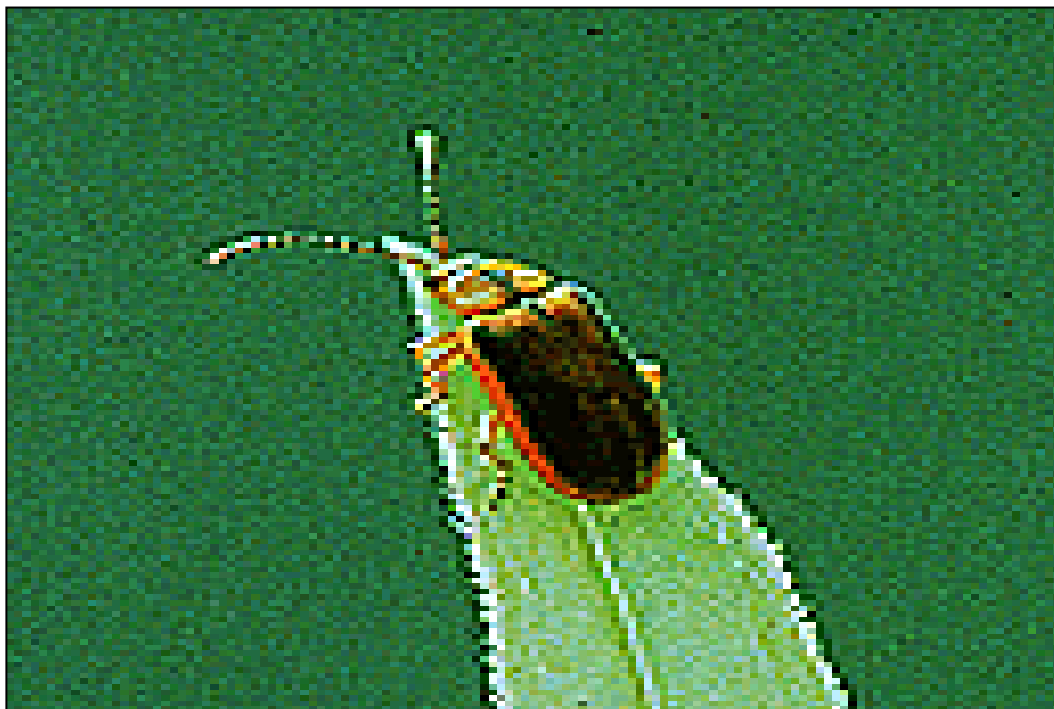
Figure 57. *Galerucella* sp. The “Purple Loosestrife” beetle.

The land beetle, *Galerucella sp.* (Figure 57) has been effective on the treatment of shoreline Purple Loosestrife in many locations throughout the Midwest and especially in Michigan. However, these beetles usually prefer a large stand of Purple Loosestrife to promote their population. Fortunately, only a small area around Cedar Lake contained this plant and hand-pulling is recommended at this time over biological control due to the overall low abundance and biomass.

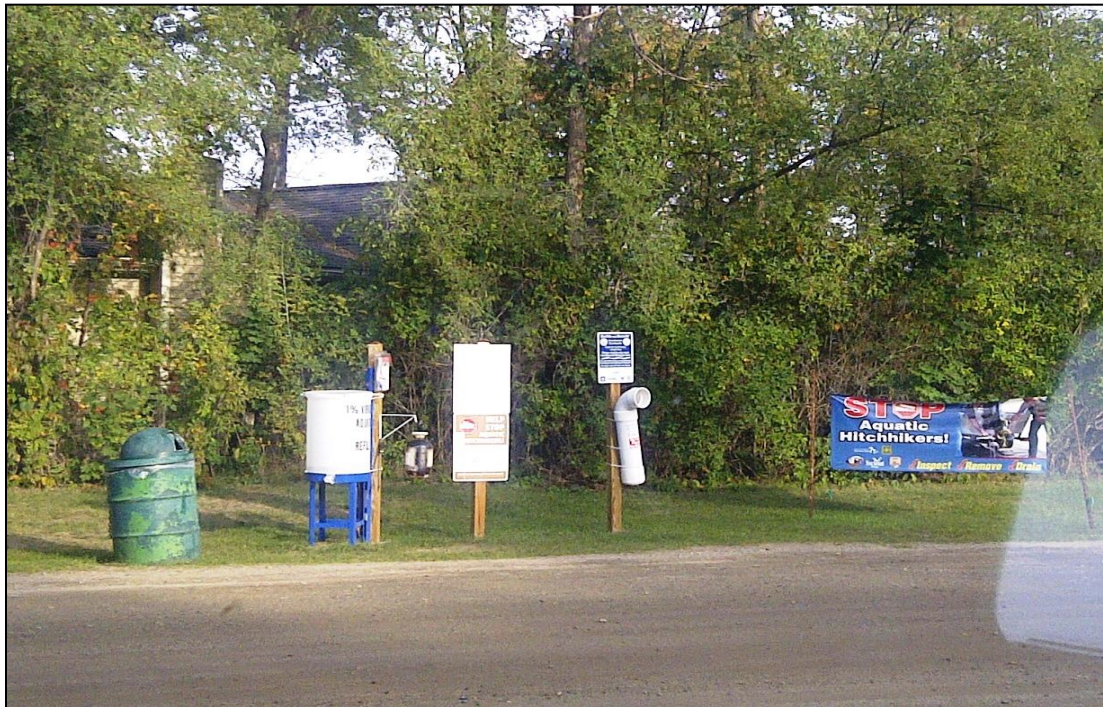
Figure 61. A boat washing station on a Michigan inland lake (©RLS).

Critical elements of this educational program include: 1) how to approach boaters, 2) demonstration of effective boat and trailer inspections and cleaning techniques, 3) the recording of important information, 4) identification of high-priority invasive species, and 5) sharing findings with others. Once a boat washing station is in place on Cedar Lake, the CLRA should work to educate the public and lake users on proper cleaning techniques and other invasive species information. A “Landing Blitz” can be held once the station is in place and the public can be invited to a field demonstration of how to use the washing station.
