2024 Data Report for Cedar Lake, Van Buren County

Site ID: 800241

Cedar Lake, Van Buren County 2024 CLMP Results

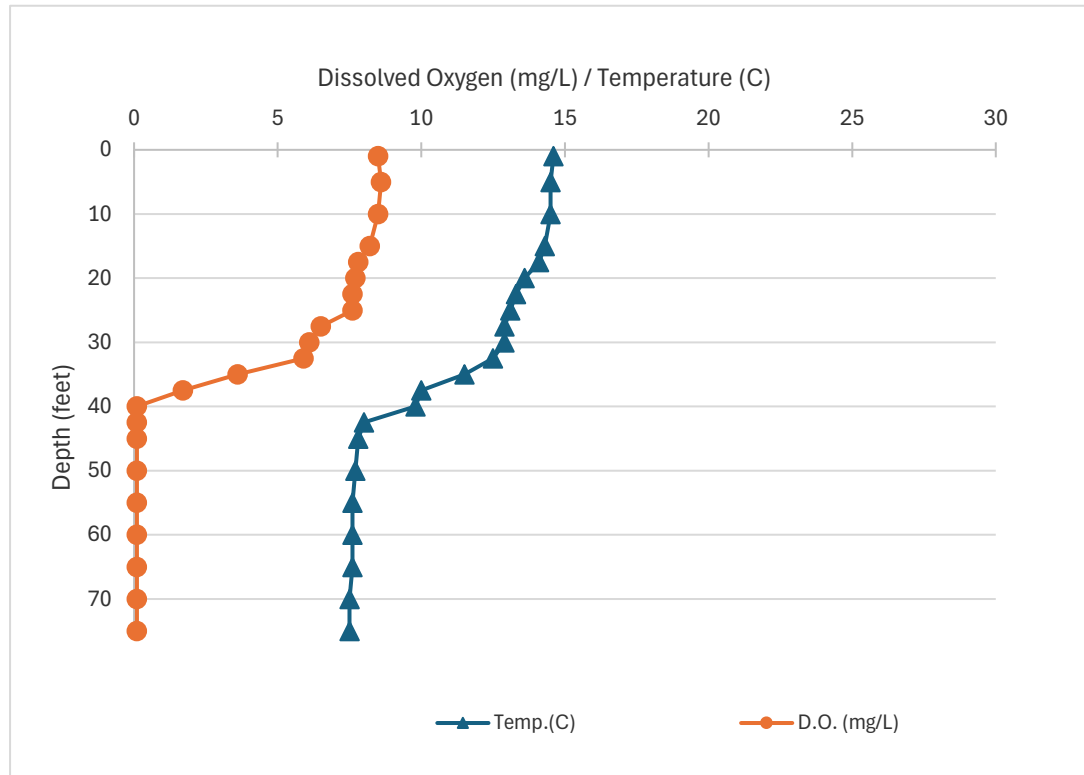
Dissolved Oxygen and Temperature Profile

Name: Cedar Lake
 County: Van Buren
 Site ID: 800241
 Date: 11/7/2024

Depth (ft)	Temp.(C)	D.O. (mg/L)
1	14.6	8.5
5	14.5	8.6
10	14.5	8.5
15	14.3	8.2
17.5	14.1	7.8
20	13.6	7.7
22.5	13.3	7.6
25	13.1	7.6
27.5	12.9	6.5
30	12.9	6.1
32.5	12.5	5.9
35	11.5	3.6
37.5	10	1.7
40	9.8	0.1
42.5	8	0.1
45	7.8	0.1
50	7.7	0.1
55	7.6	0.1
60	7.6	0.1
65	7.6	0.1
70	7.5	0.1
75	7.5	0.1
